Subject: Report of Load Tests
American Step Pulling Irons
MACTEC project 501 50-2-0240

As you authorized MACTEC Engineering and Consulting of Georgia, Inc (**MACTEC**) performed load tests on Pulling Irons supplied by American Step Company, Inc (American Step). This report describes the tested items and presents the testing procedures and the results.

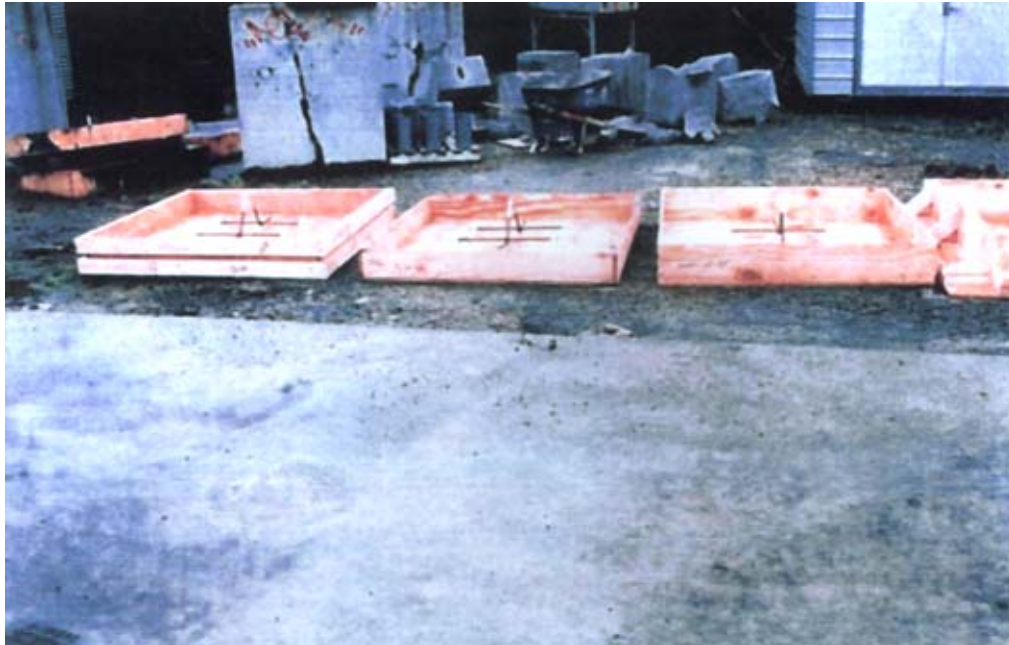
Photo 1. Forms before concrete placement

As instructed by American Step, each of the Pulling Irons was encased in cast in place concrete rectangular prisms (test blocks), which were constructed at our Atlanta, GA laboratory. Wooden forms were made, a 24" long, #4 rebar was tied into the bends at the base of each Pulling Iron, the Pulling Iron and rebars were secured 1" above the floor of the form in order to prevent displacement during concrete placement and concrete was placed into the forms. The test blocks were unreinforced except for the 2, 24" long, #4 rebars. The bottom of the sleeve in the acute

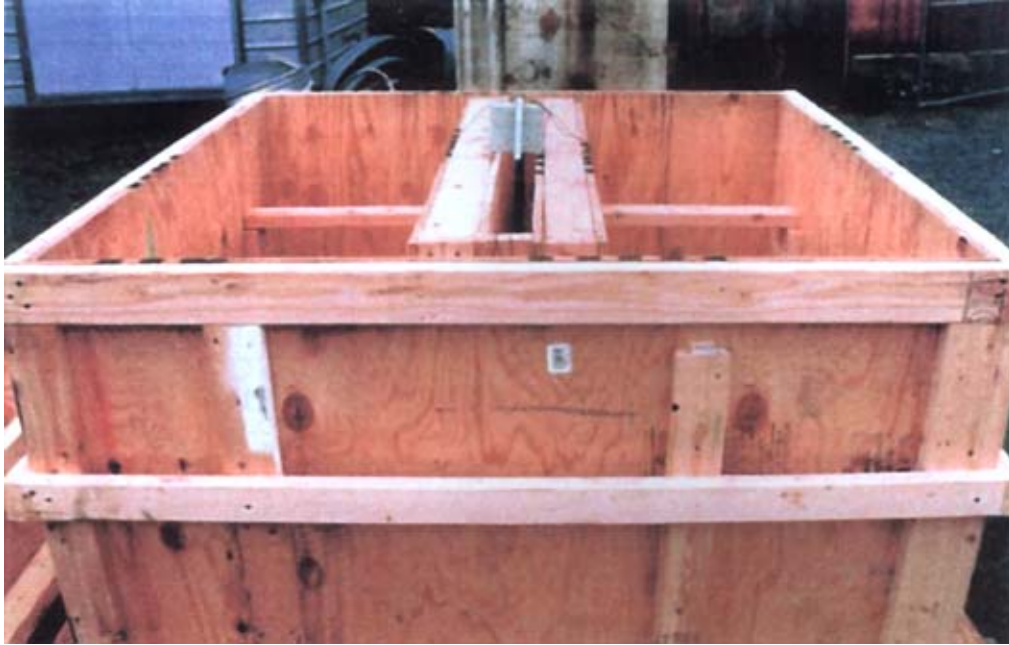
Photo 1. The 44" pulling iron for septic tank. Note block out in form that caused the pulling iron to be embedded in 3" thick wall of concrete.

* Note: This model was also tested for application in the septic tank industry. The pulling iron was embedded without the 24" long, #4 rebars in a 3" thick wall of concrete that was 40" deep and 60" long. This specimen is shown in Photo 3.

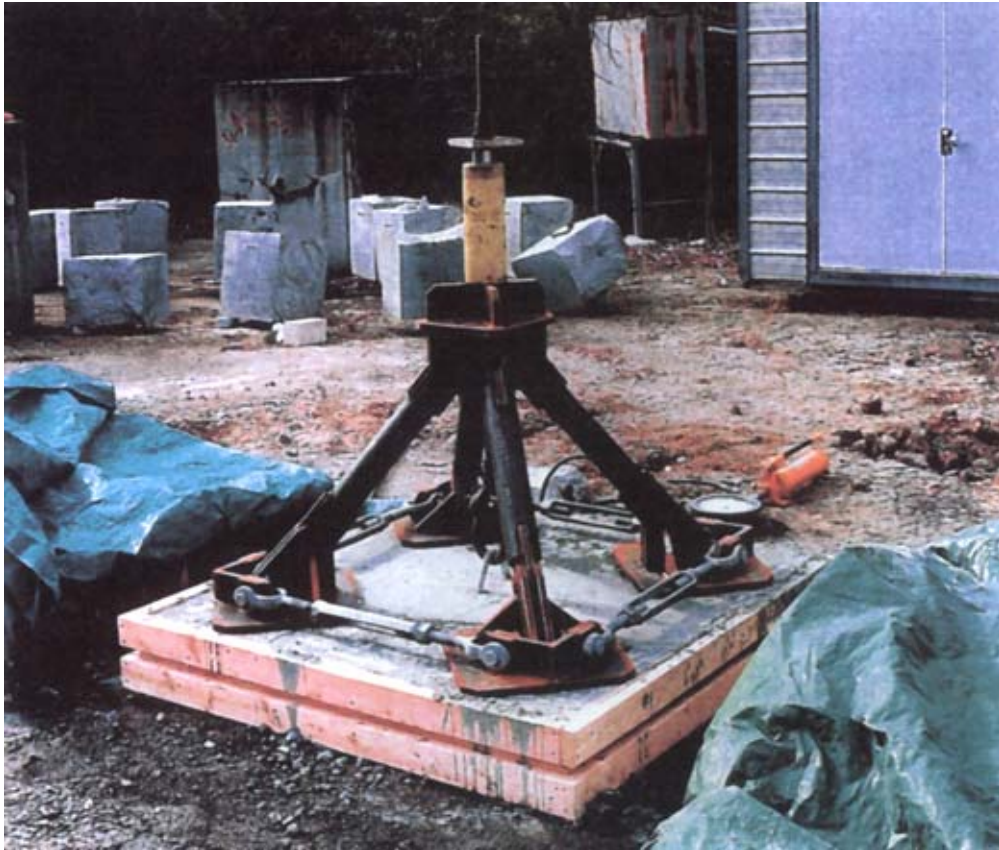
Photo 4. Load frame, ram, and jack

The pull out capacity was determined by engaging the loop formed by the acute angle in the Pulling Iron and imposing a load perpendicular to the surface of the concrete from which the device protruded. This loading direction was chosen because it was thought to be more severe than loads that are imposed away from the concrete surface at other angles. The load was imposed with a calibrated 30 ton jack (except for the 44 inch double strand which used a 60 ton jack) supported by a 4 legged frame, which reacted against the surface of the concrete. As the load was applied, the surface of the concrete was observed for evidence of distress. The ultimate pull out capacity was recorded. In each case the failure was abrupt. The load test procedure is shown on an attached photograph.

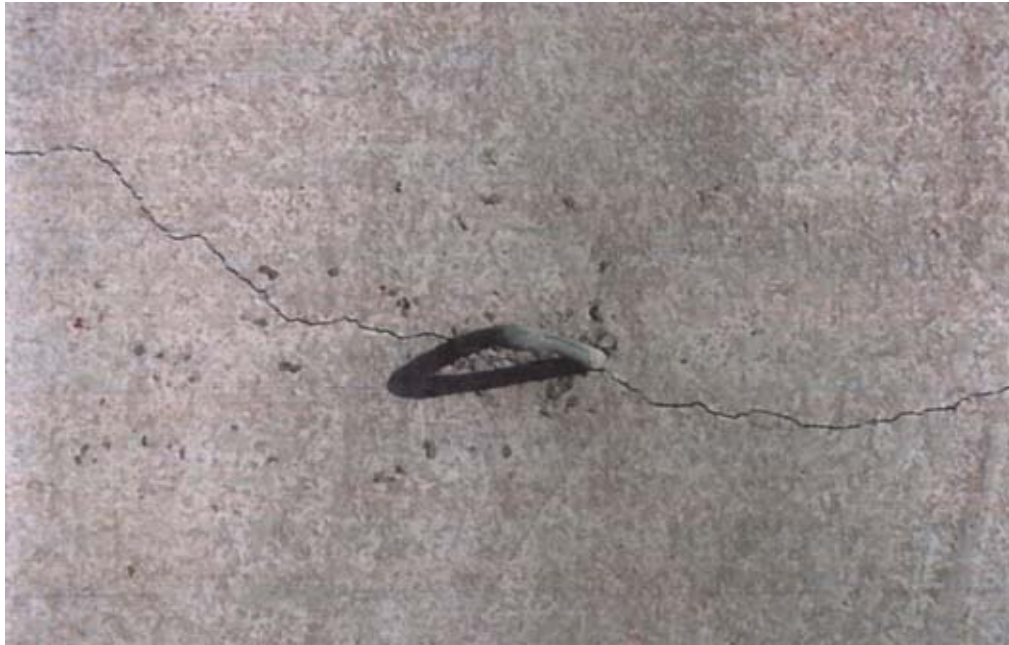
Photo 5. Typical tensile failure in concrete which caused a vertical crack

Pulling Iron Identification	Concrete Cylinder Compressive Strength, psi	Ultimate Tensile Load, pounds	Failure Mode
10 1/2"	1590	14,100	Concrete split vertically over legs of pulling iron
10 1/2"	2580	15,670	Same
10 1/2"	4460	17,090	Same
12"	1590	19,200	Same
12"	2490	25,500	Same
12"	4460	30,770	Same
15"	4460	39,460	Same
18"	4460	55,700	Same
44" Septic Tank	3000	57,840	Pulling Iron Strand failed
44"	4010	56,840	Pulling Iron Strand failed
44" Double	Greater than 4460	117,610	Pulling Iron Strand failed

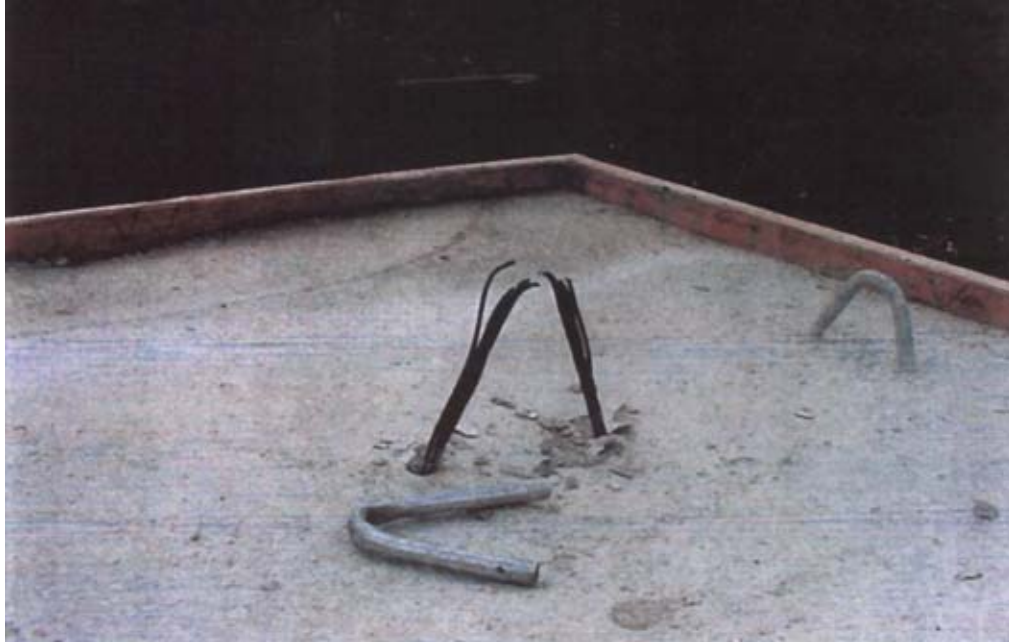
Photo 6. Pulling iron strand failure
